HOUSATONIC RIVER BASIN  
BECKET, MASSACHUSETTS

GREENWATER POND DAM  
MA 00204

PHASE I INSPECTION REPORT  
NATIONAL DAM INSPECTION PROGRAM

DEPARTMENT OF THE ARMY  
NEW ENGLAND DIVISION, CORPS OF ENGINEERS  
WALTHAM, MASS. 02154

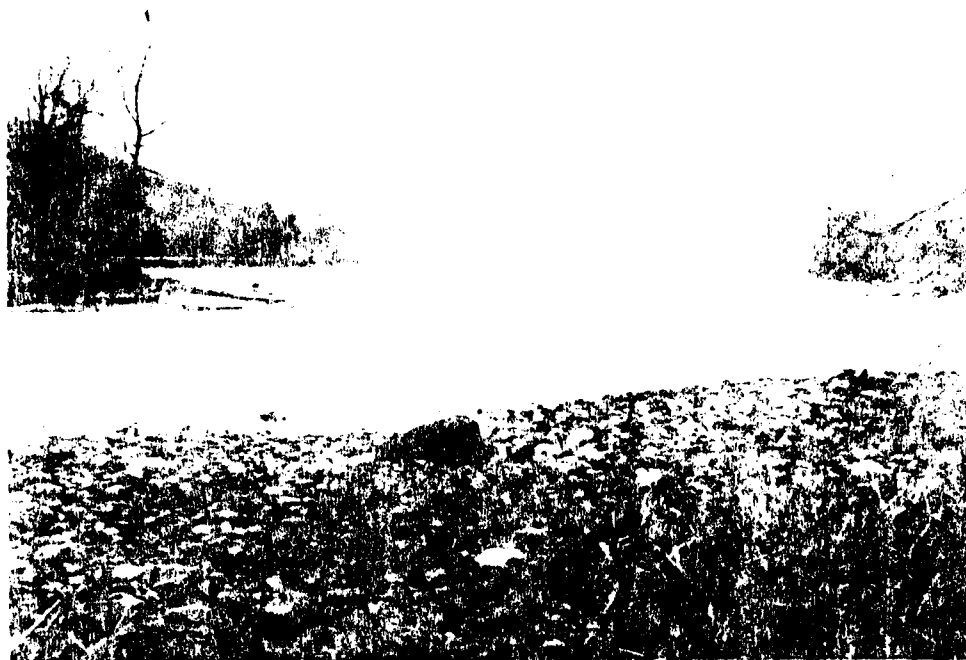
Photograph 15 - View of Greenwater Pond looking upstream (east) from the dam.

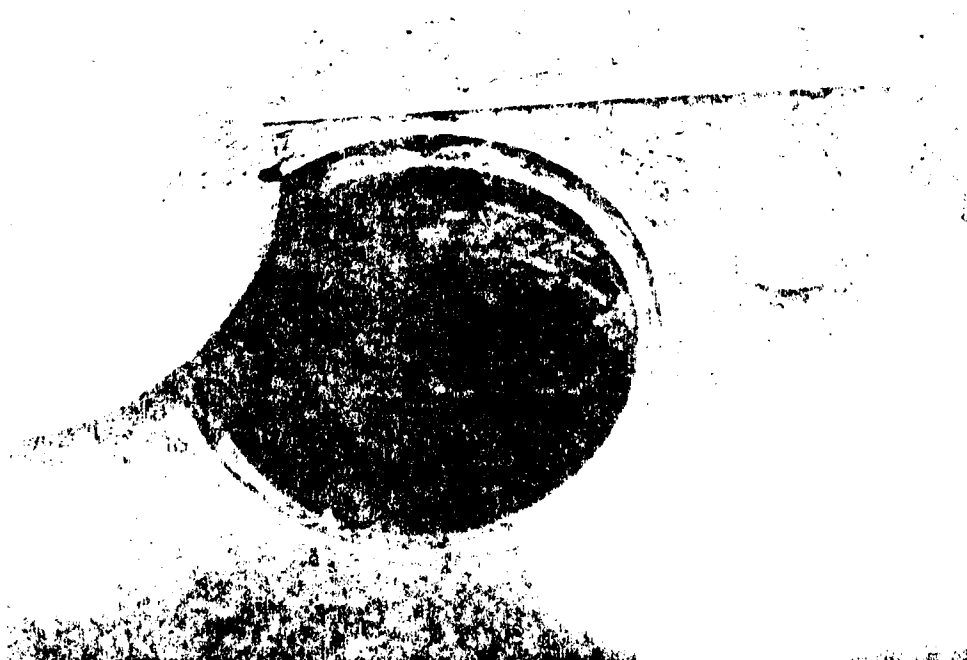
Flow through the outlet conduit is controlled by a 20" single gate valve in a mortared brick manhole located on the crest of the embankment approximately 16' north of the spillway. The manhole appears to be in good condition with no seepage noted in the sides above the water level at the bottom. The source of the water in the manhole is not known. There was water in the manhole 12.8' below the rim, approximately 1½ feet deep, at the time of the inspection. The inside diameter of the manhole at the bottom is 4'. There are no apparent cracks in the manhole. There is heavy rust scale on the ladder rungs but they appear sound. The manhole has a heavy cast iron frame and cover, which is in good condition (see Photograph 12, Appendix C). It has been reported by the owner that roots from the willow trees on the upstream face of the northerly embankment have penetrated and clogged the outlet conduit upstream of the gate valve.

Photograph 12 - 20" Gate valve access manhole.

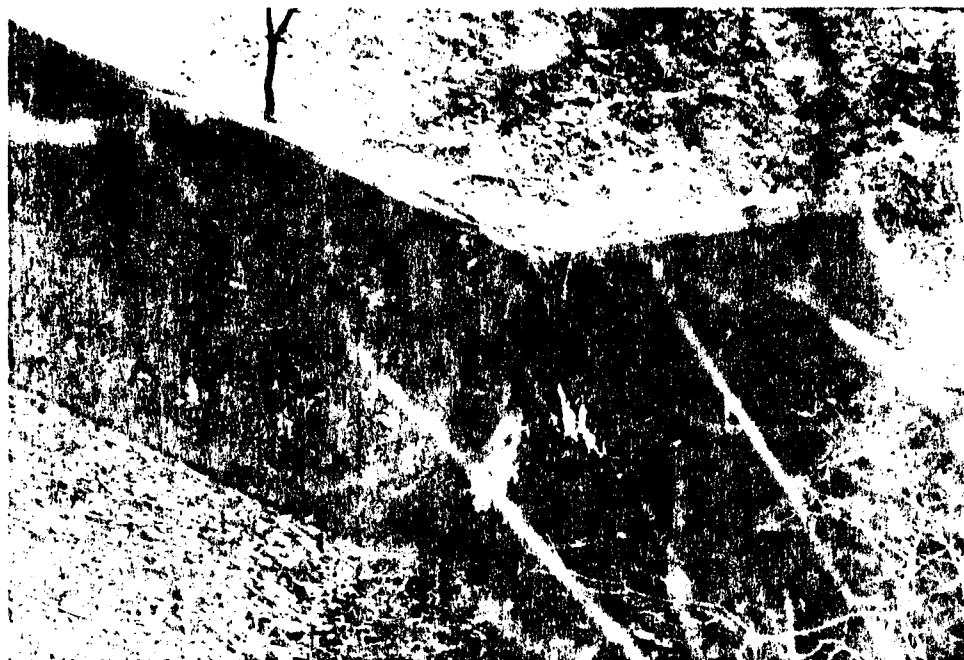
There is a small crack across the top of the northerly downstream spillway wall. This crack continues down the face of the wall and shows efflorescence (see Photograph 8, Appendix C). There is a large crack underneath the 20" outlet conduit on the northerly spillway wingwall with a rust colored leachate seeping from the crack (see Photograph 6, Appendix C). There is a large diagonal crack at the corner of the southerly downstream spillway wingwall. The cracked wingwall is displaced vertically approximately 1". It appears that surface water flowing down the slope collects in this area. This condition plus frost action may be responsible for cracking the wingwall and pushing it out of plumb (see Photograph 9, Appendix C).

Photograph 9 - Southerly spillway chute wingwall. Note crack, displacement and erosion behind wall.

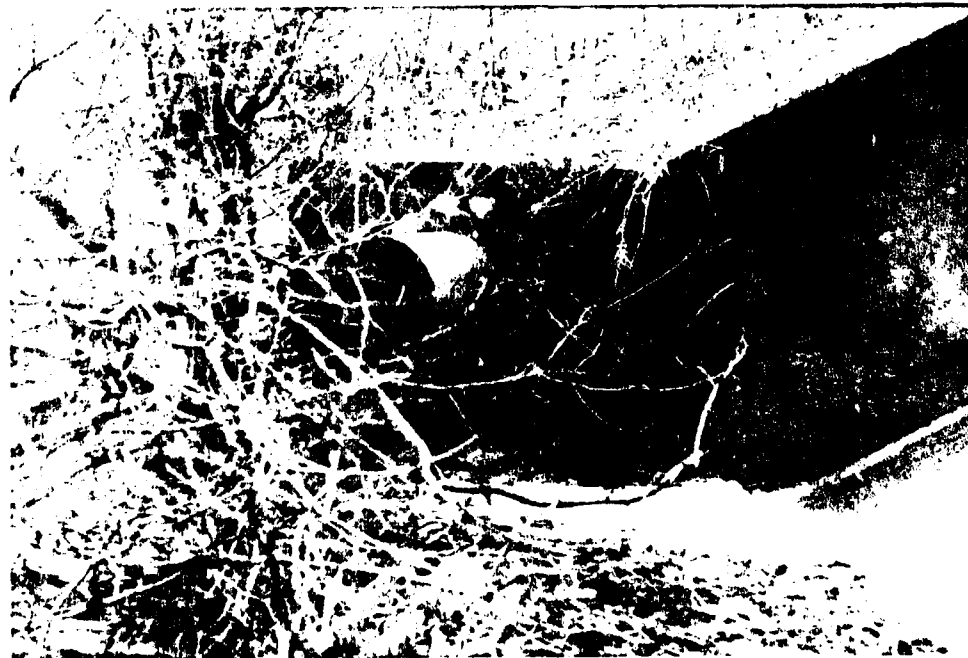
The downstream end of the 20" conduit is encased in a concrete yoke at the spillway wingwall (see Photograph 6, Appendix C). There is cracking around this yoke. There is a crack that goes up the upstream side and across the top of the wingwall. There is another large crack underneath the conduit. Seepage is coming from this crack on the order of 1 to 2 gallons per minute. The seepage appears clear; however, the area is characterized by a bright orange stain.

Photograph 6 - Outlet of 20" C.I. pipe at northerly spillway d/s  
wingwall. Note cracks around yoke and seepage stain  
from large crack beneath conduit.

- Design repairs to the concrete spillway wingwalls including the crack and seepage under the 20" outlet in the northerly spillway wall.
- Design repairs for the inoperable draw-down conduit.
- Design procedures and supervise the removal of all trees on both upstream and downstream slopes of the embankment and for a distance of at least 25' downstream of the toe of the embankments.
- Investigate the sink hole at the crest of the northerly upstream embankment in order to determine if this is associated with seepage in the access manhole or along the draw-down conduit.
- Design repairs to the spillway bridge. This should be done immediately upon receipt of this report.
- Design repairs to the areas of settlement between the embankment and the top of the spillway walls, particularly for the wingwalls at the downstream toe.

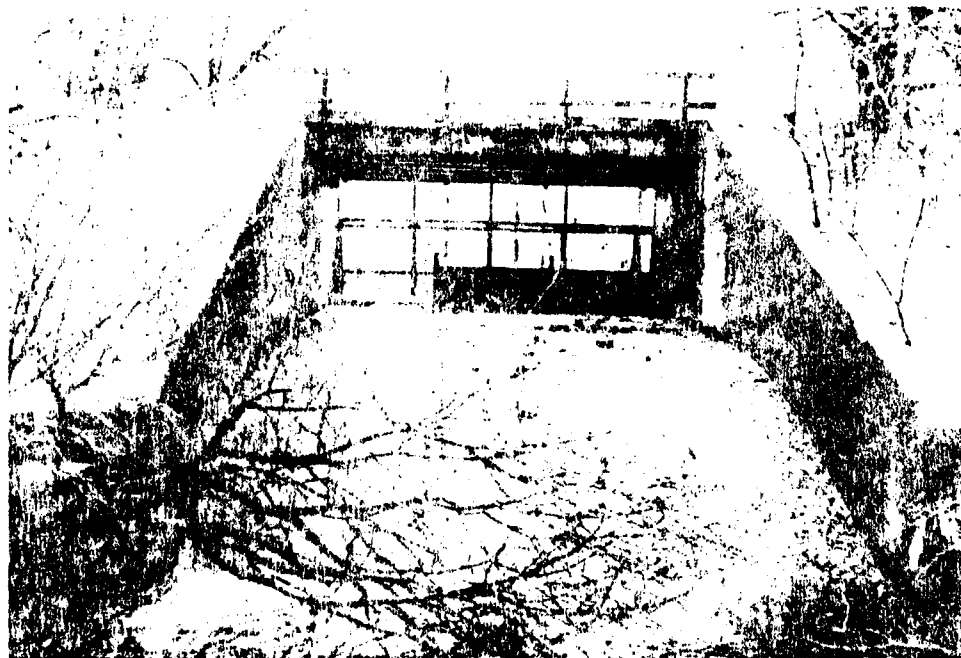
The spillway bridge is built with wood stringers, 14" deep x 4" wide. These stringers rest on concrete masonry block which in turn rest on a seat in the spillway walls. These concrete masonry blocks are 5" high and some are broken. The bridge seat is 12" wide and has accumulated soil and debris. The seven wood stringers show evidence of decay where they rest on the concrete blocks. There appear to be some old anchor bolts on the bridge seat which are not being used. There are four stringers which are cracked near mid-span and one is deflected downward about 1".

Photograph 2 - Spillway chute. Note condition of spillway bridge, 20" conduit discharging from northerly wingwall, and large tree on crest about 5 feet from southerly spillway wall.
